Water Main and Fire Line Rehabilitation

Project Summary

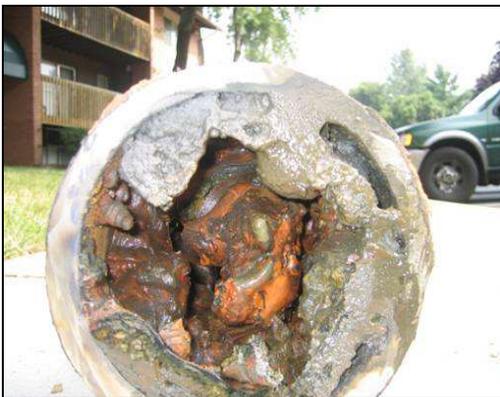
Before

Dirty brown water and poor water flow were the first clues that a mid-Atlantic commercial property owner had a problem. Then the owner was put on notice by the local fire department that the water supply lines were no longer meeting the required flow requirements. Four hydrants on the owner's property were flowing between 200 to 300 gallons per minute -- well below the 1,000 gallons per minute required by code. A section was inspected revealing the pipes were almost completely clogged with corrosion induced tuberculation.

- 1,200 linear feet of 6"/8" C/I Water Main
- System feeds water to multiple buildings and four fire hydrants
- Pipe system 70% to 90% constricted from corrosion-induced tuberculation
- System flow had fallen to 200 gallons per minute
- Full restoration took place in less than two weeks
- Restored mains now provide over 1,000 gallons per minute to all fire hydrants.

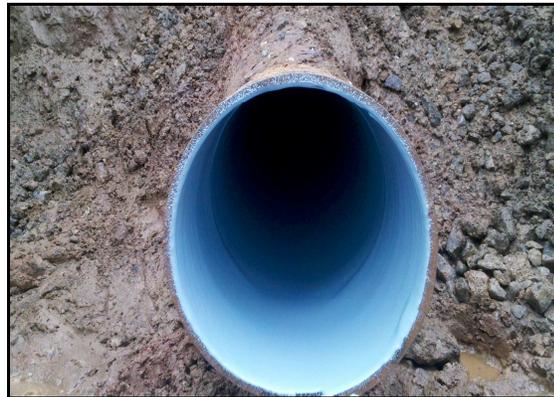
After

Results: Over 1,200 linear feet of tough access 6" and 8" cast iron mains were cleaned, lined and inspected in less than two weeks with no disruption in service to the owners' customers and only minor, temporary property impact.

The results were full restoration of all potable water and hydrant supply pipes on the property. Water flow was restored and all four fire hydrants now supply water at rates equal to or above code requirements of 1,000 gallons per minute.

Spray Lining Process: Pipes are first located, isolated and accessed. Access points are typically made at fittings (valves, tees, hydrants, bends, etc.) in conformance with applicable authorities including the local fire department. Pipes are then cleaned using a choice of several cleaning methods to eliminate debris and corrosion buildup. A post cleaning CCTV inspection is then typically conducted to check for appropriate cleanliness, water leaks coming back into the pipe, excessive service protrusions or other issues. Once cleared for lining, the epoxy lining hoses are inserted into the pipe and pulled to an exit pit at the far end of the isolated section of pipe, where the spray head is attached. The pre-calibrated spray rig is engaged, pumps actuated and the hose extracted at the rate calibrated to the size of the pipe and thickness of the lining. The spray head uses centrifugal force to spray line the epoxy resin in a uniform 360° pattern onto the inside surface of the pipe, creating a seamless and protective barrier. The system eliminates corrosion, prevents its reoccurrence, and restores water quality and flow to optimal levels. A post lining CCTV inspection ensures the application was done in accordance with expectations and requirements.
