Spincast epoxy coating

Marion (Ind.) Water Department

# WRAPPED UP

A spincast epoxy-coating system restores pressure and flow in mains for a water department in northeast Indiana

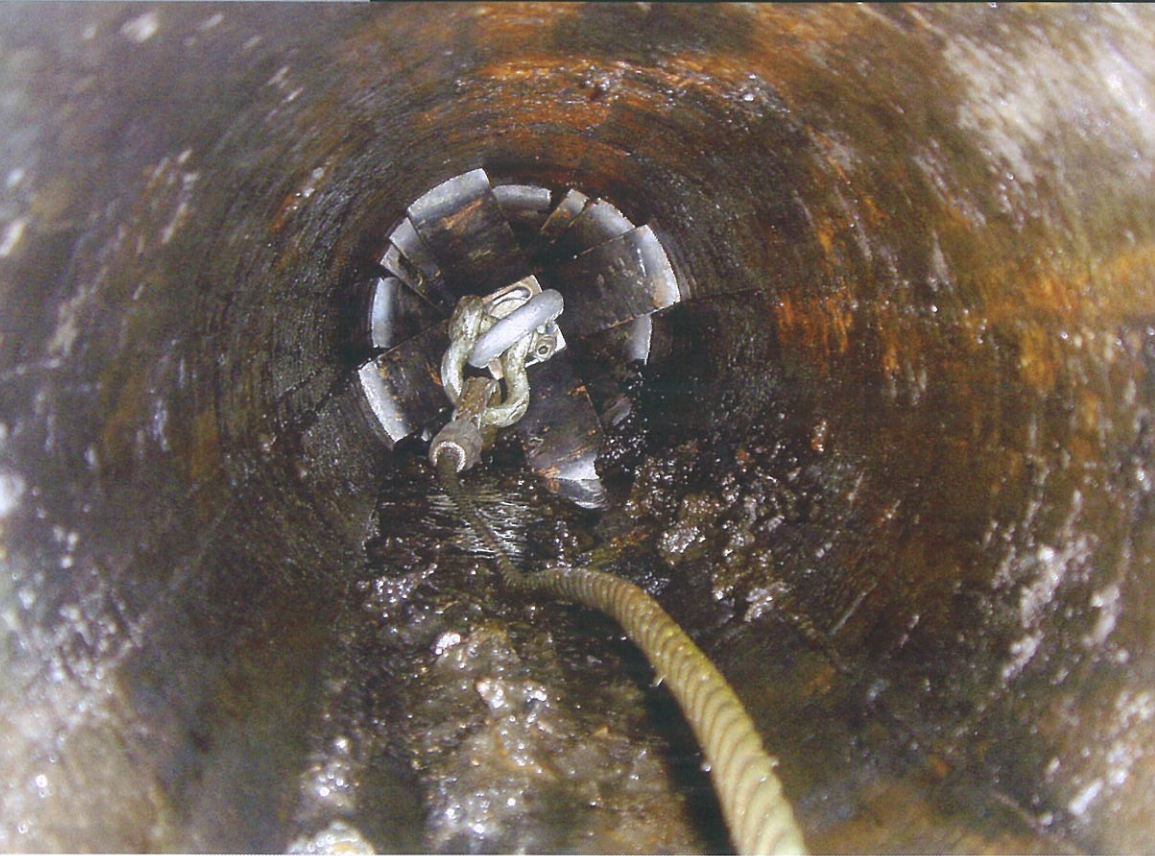
The drag scraper is pulled through the pipe to clean the walls before epoxy lining. Note the chatter marks on the walls. (Photos courtesy of Triton Lining Technologies)

Sorohan and the crew used pairs of clamped Christmas tree drag scrapers custom made in Great Britain to clean the encrustation and tuberculation.

The 75- to 100-year-old calcium tuberculation was the hardest Sorohan had ever cleaned. The crew initially took off some scraper arms to avoid removing too much material and plugging the hole. A winch pulled the tool through 12 or more times to clean some sections. Crews worked until dark, and the process took two-and-a-half days.

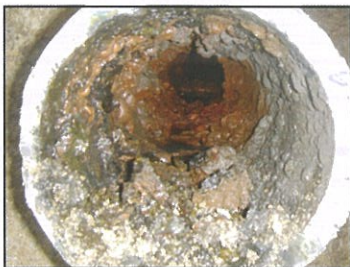
The tuberculation in the 4-inch cast-iron water main reduced flows by 50 percent.

“During previous upgrades, we spot-repaired some leaks and installed Inserta valves where needed,” says David McCollum, project specialist. “The tuberculation we saw in the removed sections reduced flows by 50 percent.”

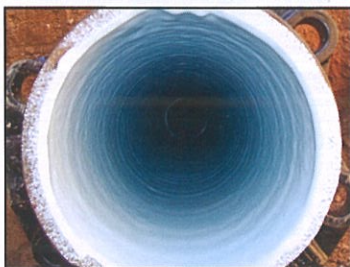
The seamless 1.2 mm epoxy resin coating eliminates corrosion and tuberculation, prevents their recurrence, restores water quality, and optimizes the C-factor (hydraulic efficiency).

A computer controlled the temperature of the epoxy and activator, pressures on each line, water temperatures, flow rates, mixing ratios, withdrawal speed and coating thickness (1.2 mm).

The seamless protective barrier eliminated corrosion and tuberculation, prevented their recurrence, restored water quality, ended customer complaints, and improved the C-factor (hydraulic efficiency) to optimal levels. "Our fire flows went from 300 to 400 gpm to 900 to 1,000 gpm," says McCollum. "This summer, we're doing a flushing program to help identify next year's coating projects." ♦

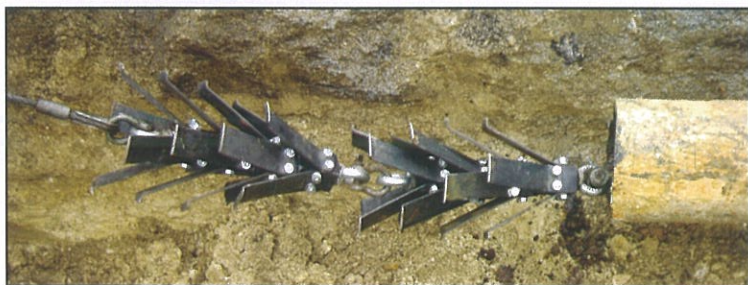
A winch system pulls pairs of clamped custom-made drag scrapers into the pipe to clean it. In Marion, Ind., the encrustation and tuberculation were so hard that it took 12 or more pulls to clean each section.
